Multidisciplinary Perspectives on Illicit Trafficking of Cultural Heritage in the EU and the MENA Region

Faces in Stone. Rock Art in the Duhok Region (Kurdistan Region of Iraq) A Seriously Threatened Cultural Heritage

Daniele Morandi Bonacossi

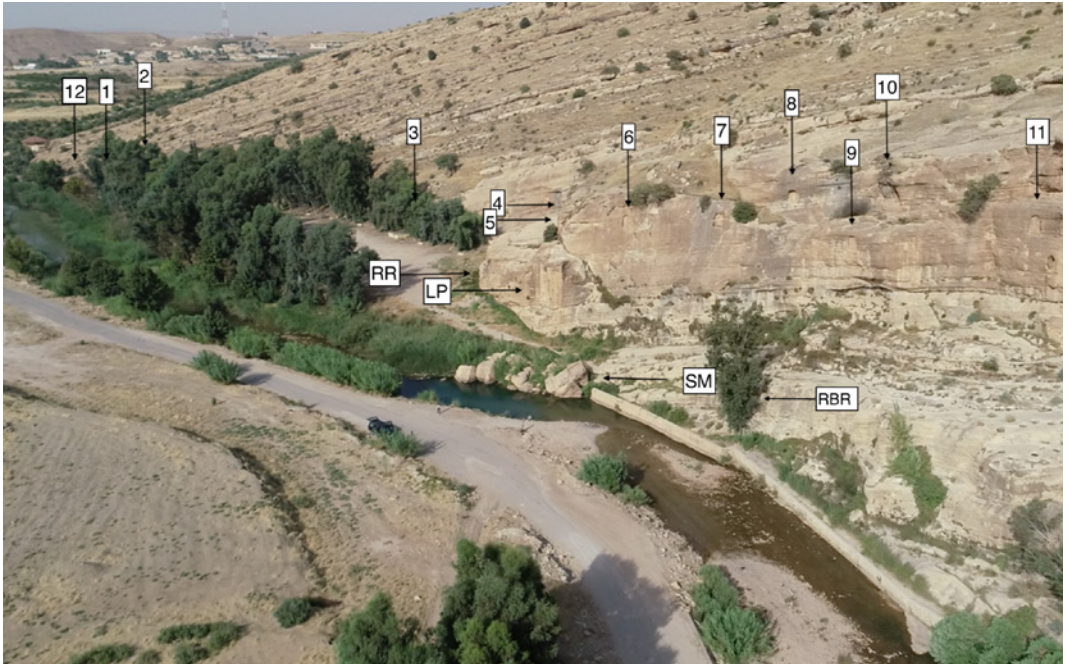
Figure 3 Drone view of the Khinis rock complex from the north-east. In the foreground, the Sculpted Monolith near the water intake of the “Sennacherib Canal” (SM) and the relief fragment on the small rock face upstream of the water intake (RBR); behind, the “Large Panel” (LP), the “Rider Relief” (RR) and the rock steles 1-12 (photography A. Savioli, October 2018)

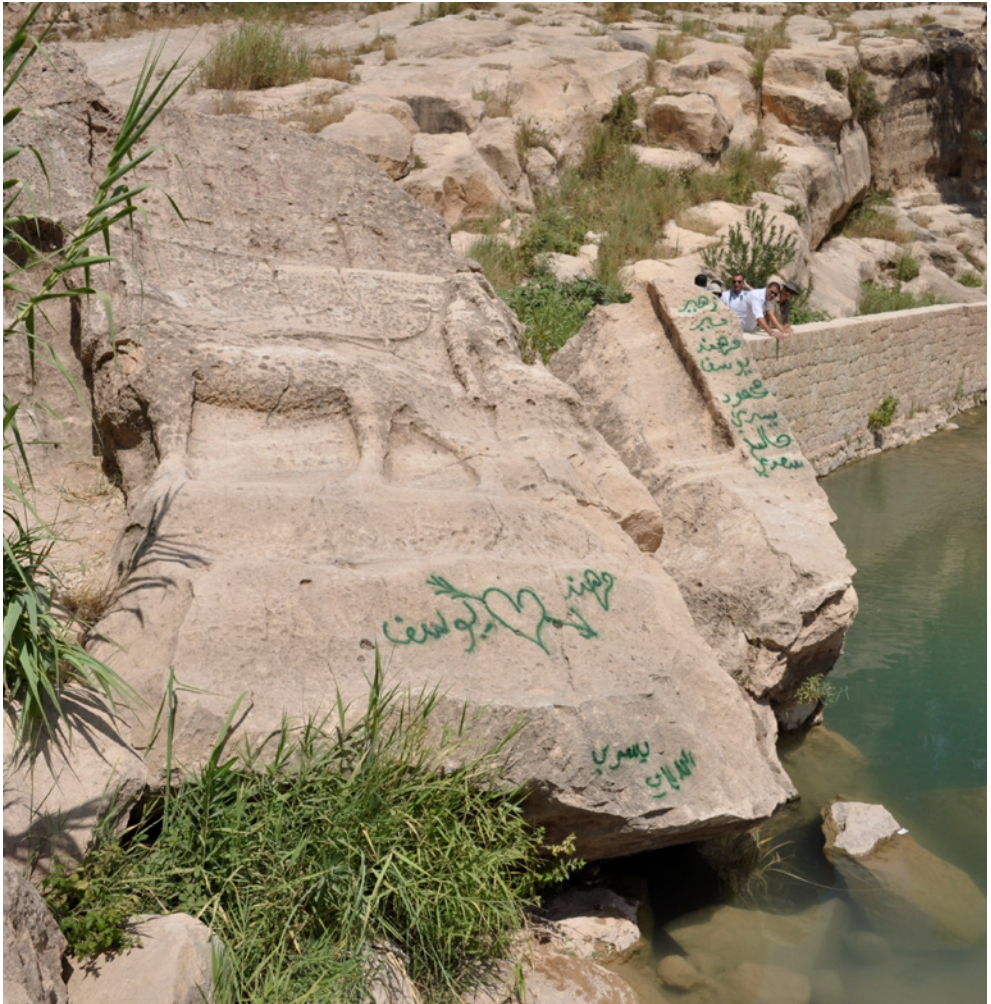
Figure 4a Graffiti on the Khinis Sculpted Monolith (photography I. Finzi Contini)

Despite the presence of guardians, Khinis has suffered from vandalism – even recently – like the appearance of writing done with oil paint from spray-cans [fig. 4]. Furthermore, in particular during summer weekends, when a lot of families go to Khinis to bathe in the Gomel (or often even to wash their cars in the river, just in front of the Assyrian reliefs), it often occurs that children climb on the bases of the “Large Panel” and “Rider Relief”: by doing this they risk damaging the carved surfaces.

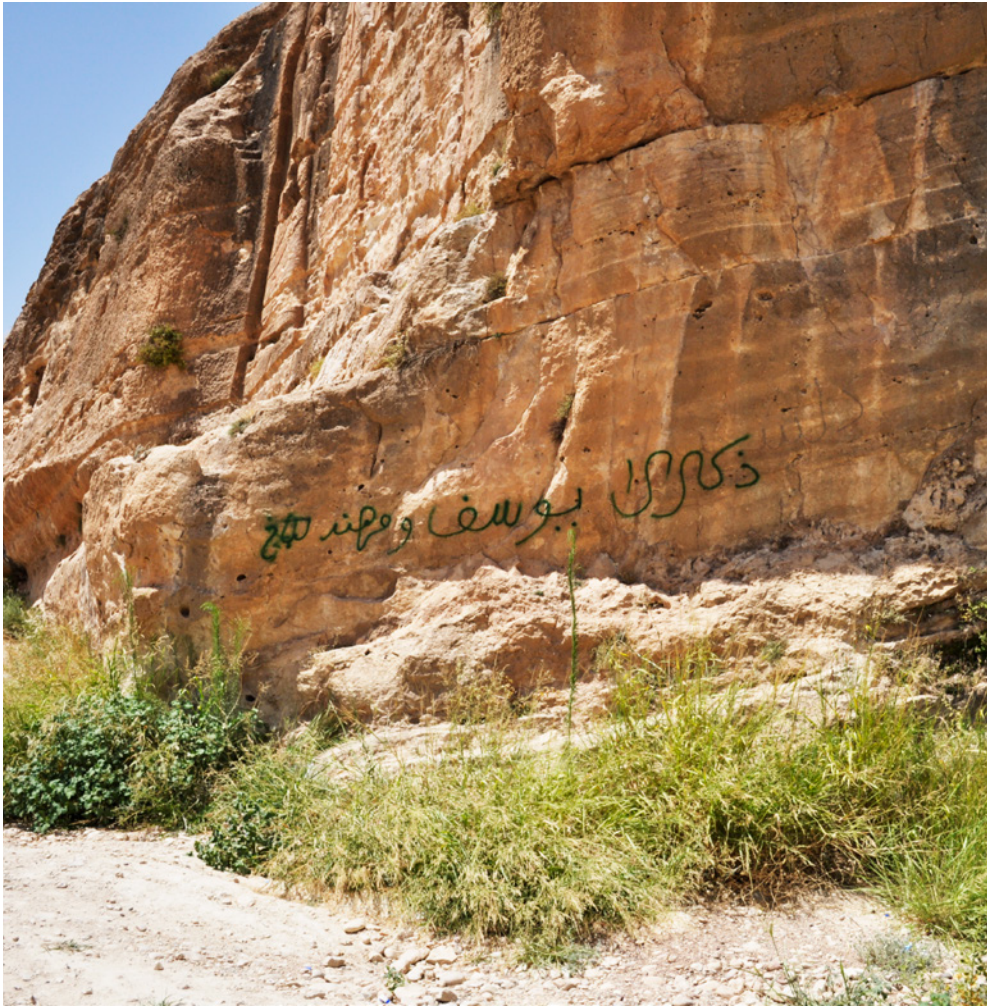
Figure 4b Graffiti at the base of the "Large Panel" (photography I. Finzi Contini)

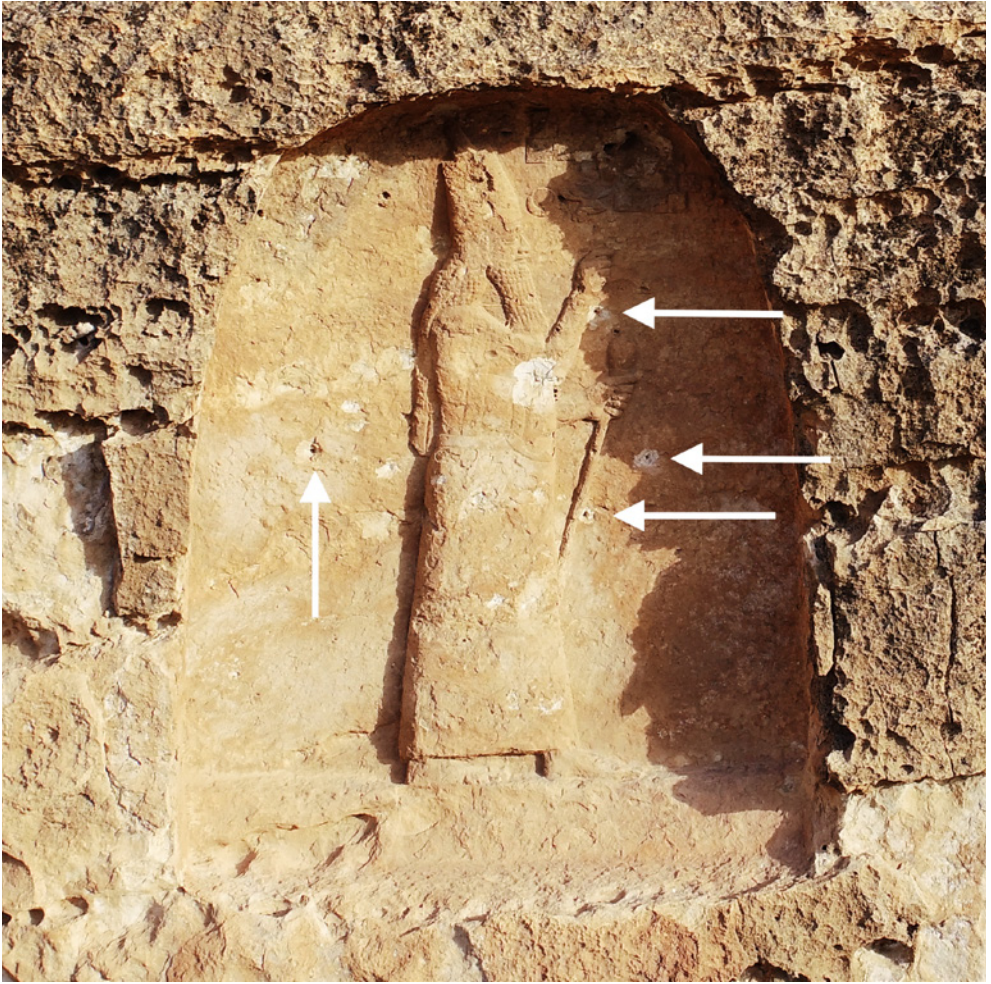
In the past, probably during the years of the Kurdish Civil War, some of the twelve niches of Sennacherib were used as targets for firearm practice exercises [fig. 5a]. These exercises have severely damaged some reliefs and certain parts of the three versions of the Bavian cuneiform inscription [fig. 5b]. At the centre of niche no. 4 there is also a deep, circular hole, seemingly a cut made in the rock to discover possible treasures hidden inside it [fig. 5c].

Figure 5a Khinis rock stele no. 9 hit by firearm bullets (photography I. Finzi Contini)

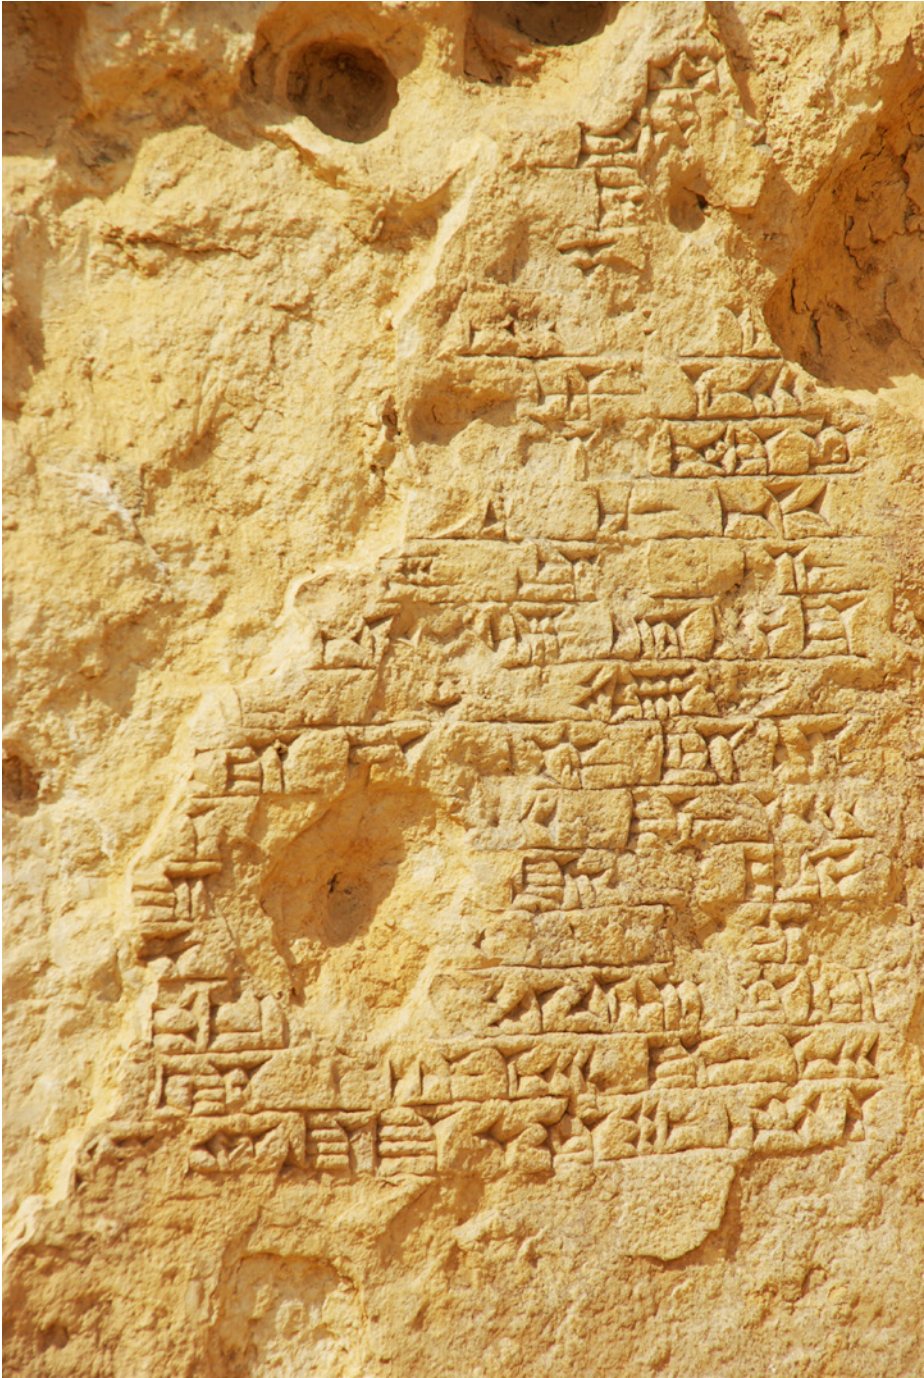
Figure 5b (On the left) One of the three replicas of the Bavian inscription engraved on stele no. 4 damaged by a bullet (photography I. Finzi Contini)

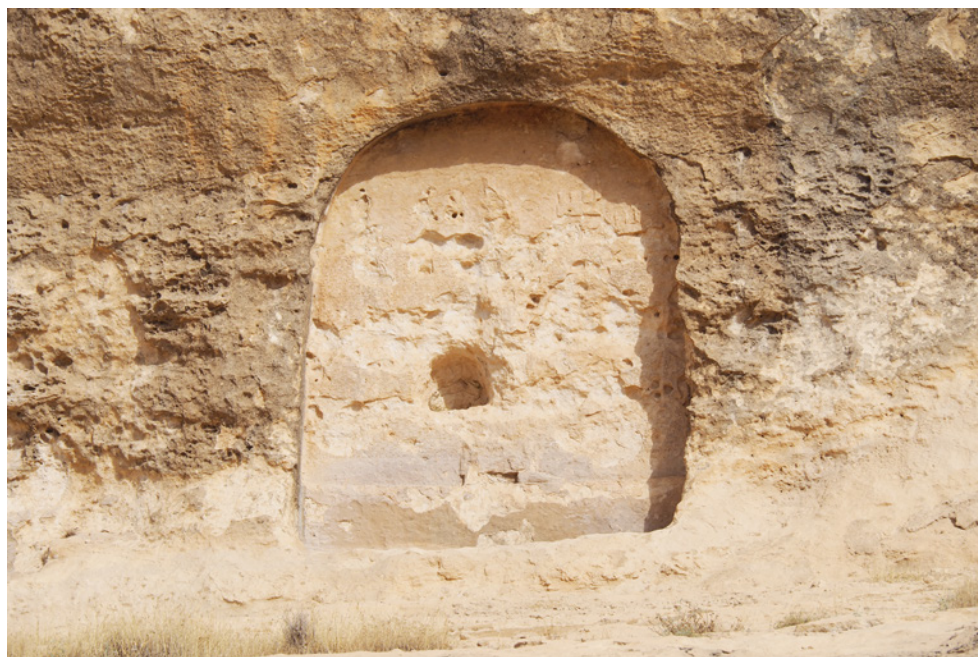
Figure 5c Stele no. 4 and the inscription damaged by the excavation of a large hole (photography I. Finzi Contini)

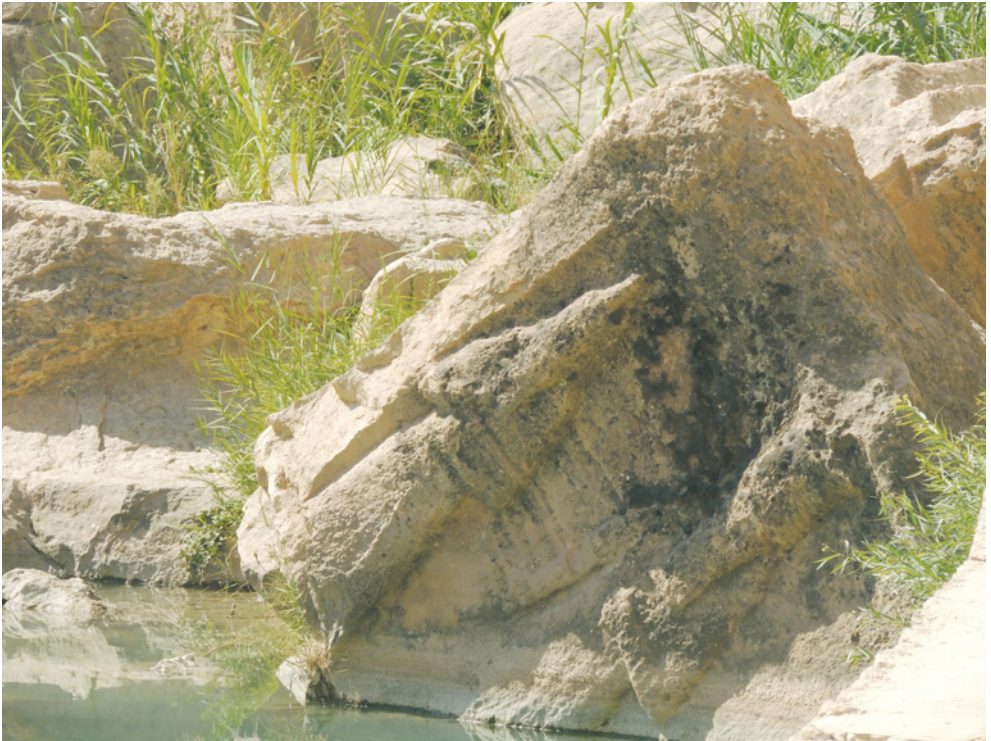
In recent years, the head and anterior part of the body of one of the two *lamassu*⁹ carved on the “Sculpted Monolith”, which signalled the canal’s water intake, have disappeared, either because they were intentionally removed by plunderers or traffickers of archaeological finds, or because they broke off due to natural or anthropic causes and fell into the River Gomel beneath [fig. 6]. The *lamassu* figure was still intact at the time of Gertrude Bell’s visit to Khinis in 1909¹⁰ and the following one of R.M. Boehmer in 1978 (Bär 2006, figs. 27-8, 32). It cannot be excluded that the disappearance of the head and part of the body of the *lamassu* might have been caused by illegal traffickers in artworks who were active in Khinis during the Kurdish Civil War between 1994 and 1997, when the site was left unguarded.

Figure 6 North elevation of the "Sculpted Monolith" with the figure of Ashur on the right and Sennacherib on the left. To the right of the sovereign's figure, you can see the abraded surface where the head and the front part of the body of one of the two *lamassu* sculpted on the monolith were originally located (photography I. Finzi Contini)

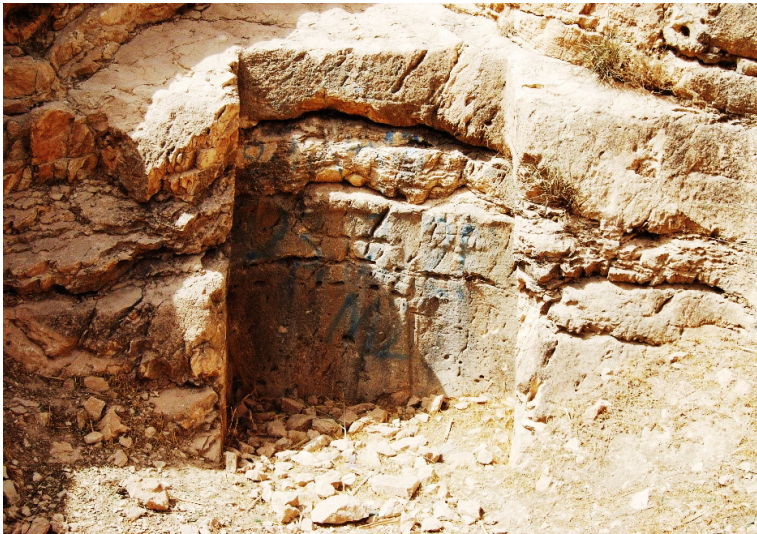
Figure 7 The relief of Shiru Maliktha and the graffiti covering it (photography R. Orazi)

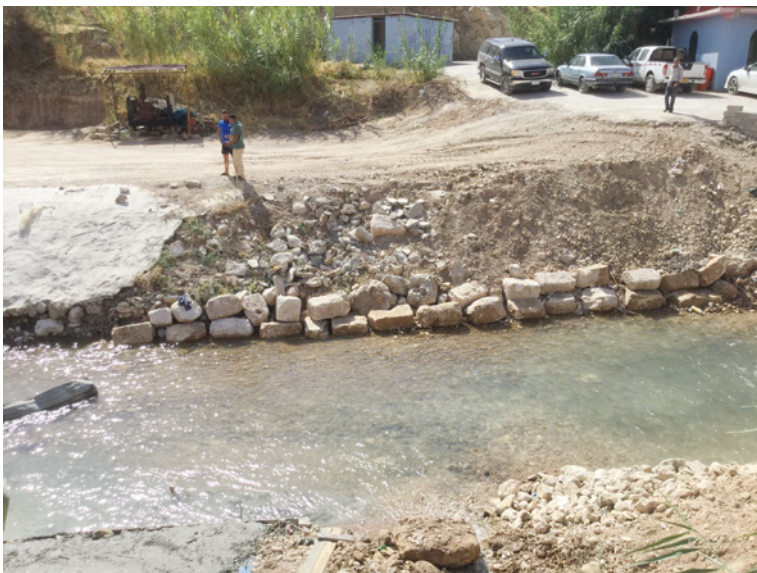
Figure 8 View of the stone blocks belonging to the masonry of the Assyrian canal of Shiru Maliktha reused in an embankment of the Wadi Bandawai (photography A. Savioli)

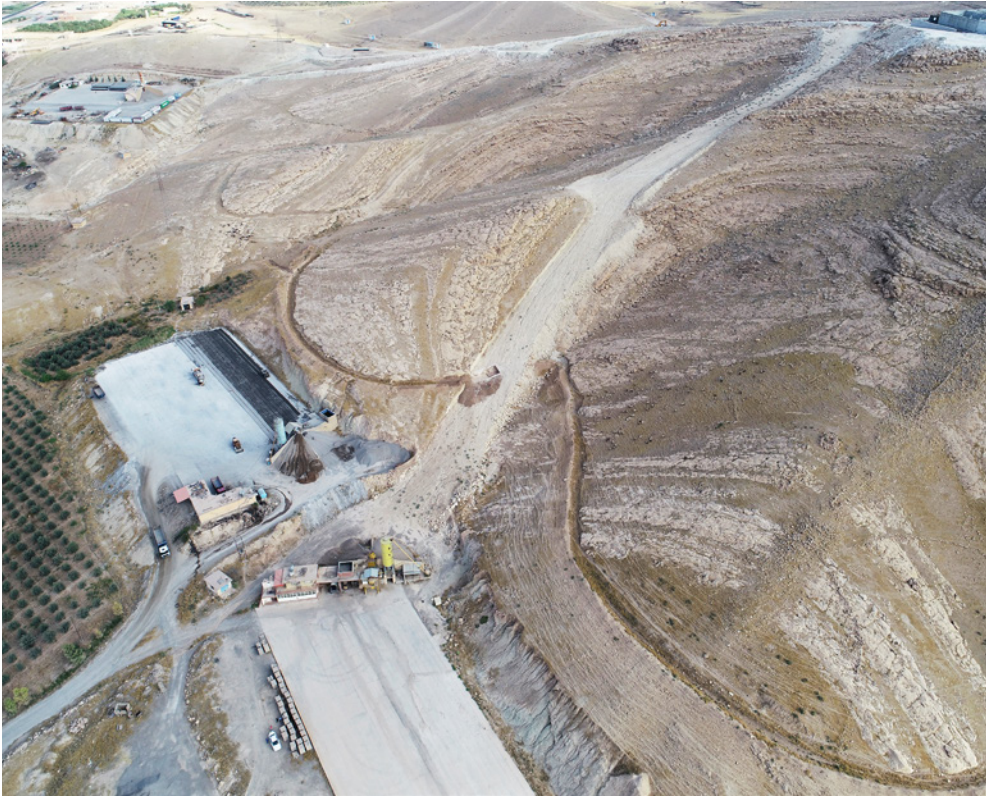
The archaeological complex in Faida is surrounded by four factories producing blocks of cement, located only a few tens of metres from the reliefs. These establishments produce thousands of cement blocks that are put to dry on large squares just downslope of the course of the Assyrian canal [fig. 9]. Furthermore, a farm where chickens are raised and a cattle shed partially occupy the canal's course [fig. 10]. In 2015 the personnel of the cement block factory ascertained that during particularly abundant winter and spring rainfalls the surface runoff from the western side of the Çiya Daka hill ridge, at the foot of which the Assyrians built their canal, flooded the squares in which the cement blocks were placed to dry. They therefore decided to empty the canal, removing the fill with a mechanical excavator [fig. 11]. The tract of the Assyrian canal located upstream of the cement factories was hence reactivated to collect the surface runoff from the hillside in order to transport it far away from the cement production area, through a secondary canal that originally branched from the Assyrian canal. This excavation operation of the canal has put to risk the integrity of its course, but luckily caused only limited damage.

Figure 9 Drone view of three of the four concrete block factories built close to the Assyrian canal at Faida. Note the new aqueduct built in 2018 (top right) and the large trench for housing the water pipe that cuts the canal in two (photography A. Savioli)

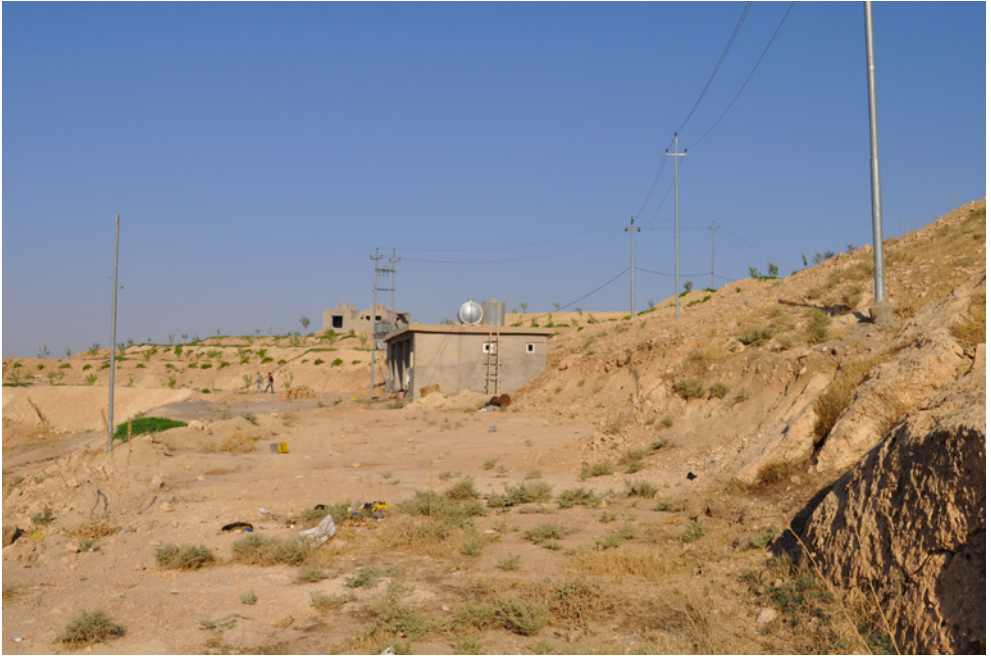
Figure 10 View of the Assyrian canal at Faida entirely filled with earth and debris in the foreground, and the terraces created to house a poultry farm and a cattle shed (photography D. Morandi Bonacossi)

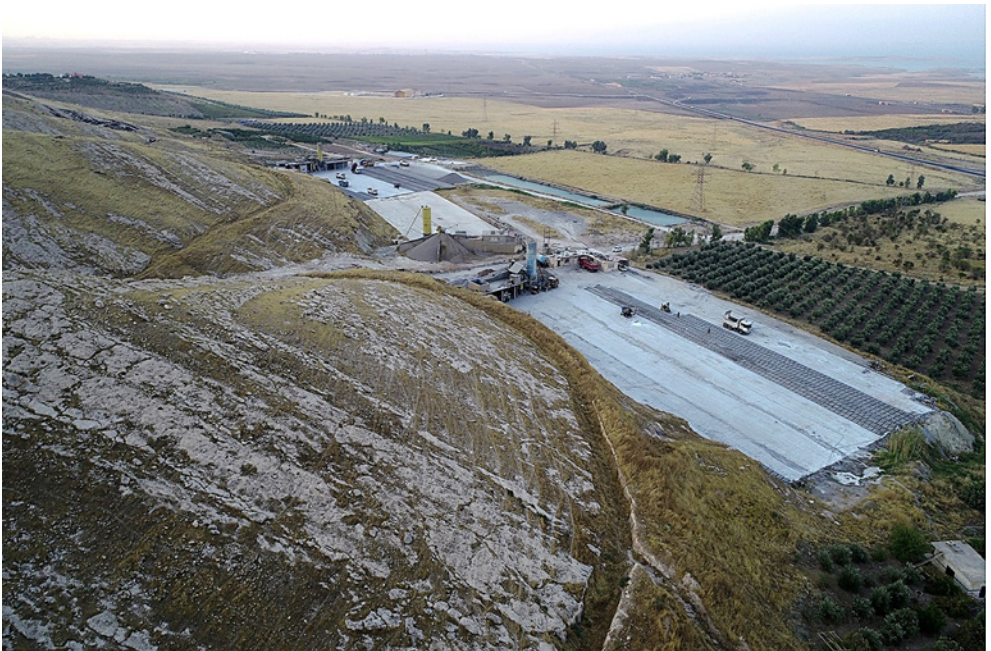
Figure 11 Drone view of the section of the Assyrian canal at Faida emptied in 2015 by the staff of the concrete block factories to be used as a drainage channel for surface runoff (photography A. Savioli)

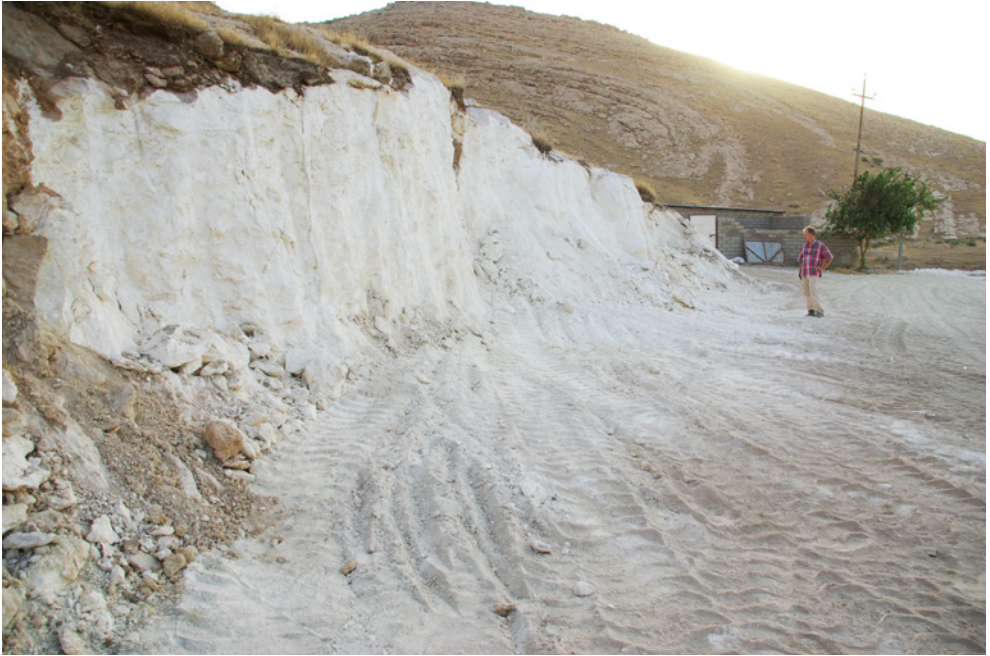
The most serious episode of destruction of the canal and the Assyrian reliefs occurred in 2017. The enlargement of a cattle shed located just a few metres from the canal involved demolition of the rocky hillside in which the canal was excavated [fig. 12]. Unfortunately, in that exact spot there was a relief (Panel no. 9). Its upper part, that above the depiction of the sacred animal figures carrying the Assyrian deities' statues on their backs, was completely removed and destroyed by the bulldozer [fig. 13]. Fortunately, the prompt intervention of the Duhok Antiquities Directorate impeded the cattle shed's enlargement, thereby permitting the recovery and documentation of the surviving portion of the relief.

Figure 12 View of a section of the Faida canal devastated by excavation of the rocky hillside in which the canal was dug. The position of the person in the image indicates the location of buried Panel no. 9, which was partly destroyed by this intervention. The cattle shed is in the background (photography A. Savioli)

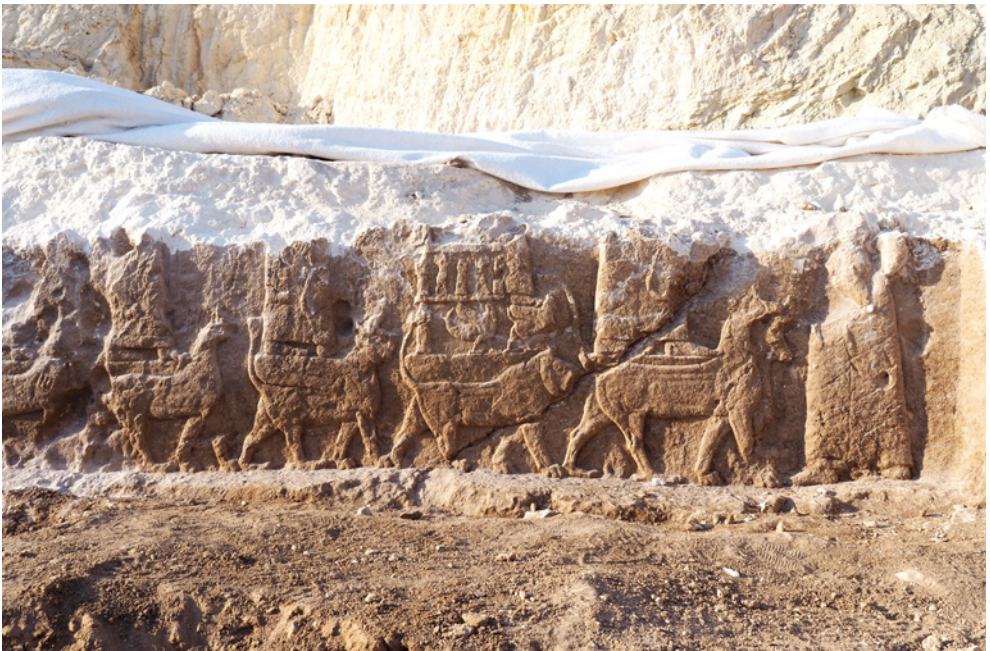
Figure 13 Faida Panel no. 9 largely destroyed by the preparation work in the area intended to house an extension of the cattle shed (photography A. Savioli)

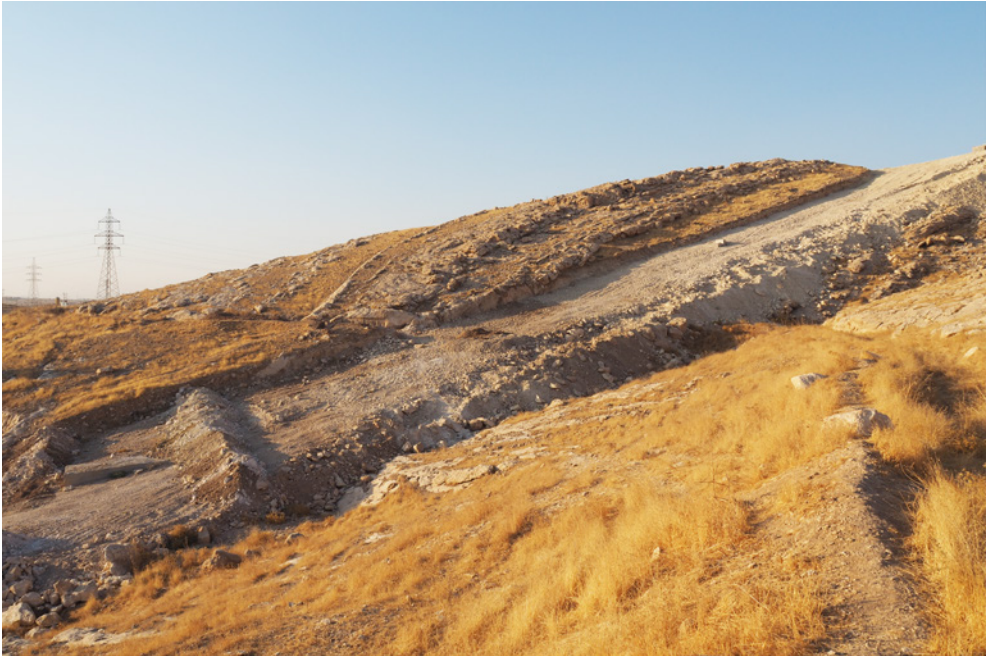
The following year, the construction of a new aqueduct in Faida by “GIZ Water Projects” cut the Assyrian canal into two. The trench dug to contain the pipe installed to distribute water supplied by the aqueduct to the residents of the village missed one of the panels by only a few metres [fig. 14].¹⁶

Figure 14 View of the huge trench for the installation of the pipeline for the new Faida aqueduct that cuts the Assyrian canal in two. In the background, notice illegally uncovered Panel no. 4 (photography A. Savioli)

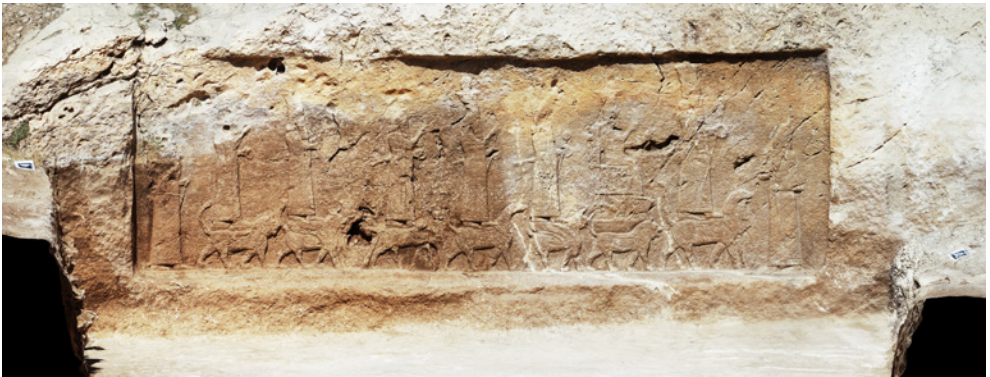
Furthermore, in May 2012 an illegal excavation of one of the ten reliefs found so far was noted. Fortunately, this illegal action was stopped by the emergency intervention of the Duhok Antiquities Directorate and of KRG security forces (Asaish). The carved panel only suffered slight damage caused by incautious and non-professional excavation procedures [fig. 15].

Figure 15 Faida Panel no. 4 after excavation by the “Kurdish-Italian Faida Archaeological Project”. The right part of the panel was unearthed by clandestine excavators. On the right side of the illegally excavated relief, note the numerous scratches on the surface caused by the use of unprofessional excavation practices (photography A. Savioli)

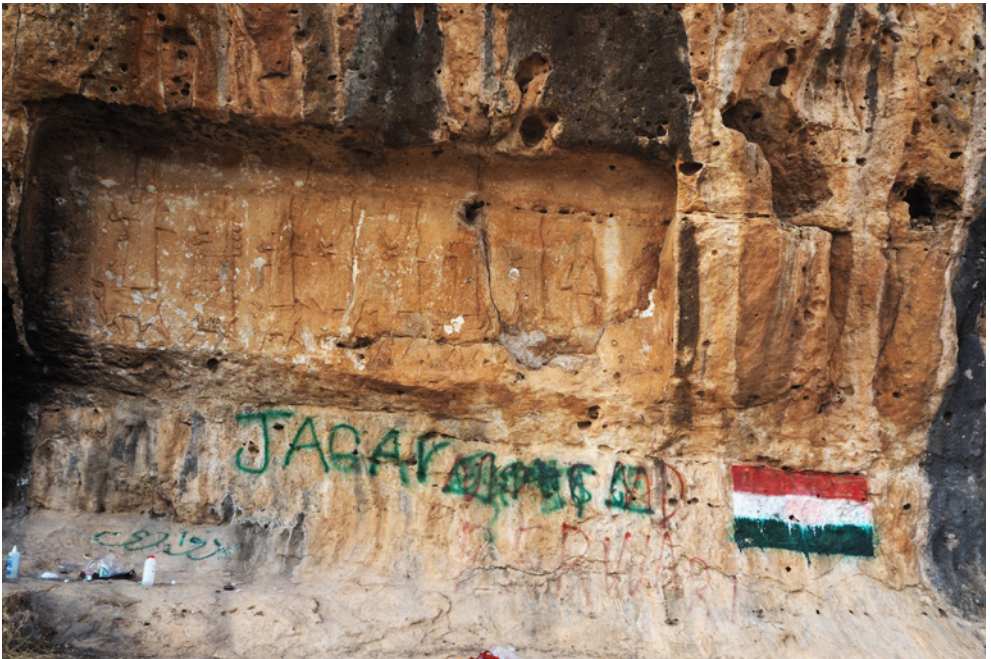
Figure 16 Maltai Panel no. 2 with one of the painted Kurdistan flags and graffiti (photography I. Finzi Contini)

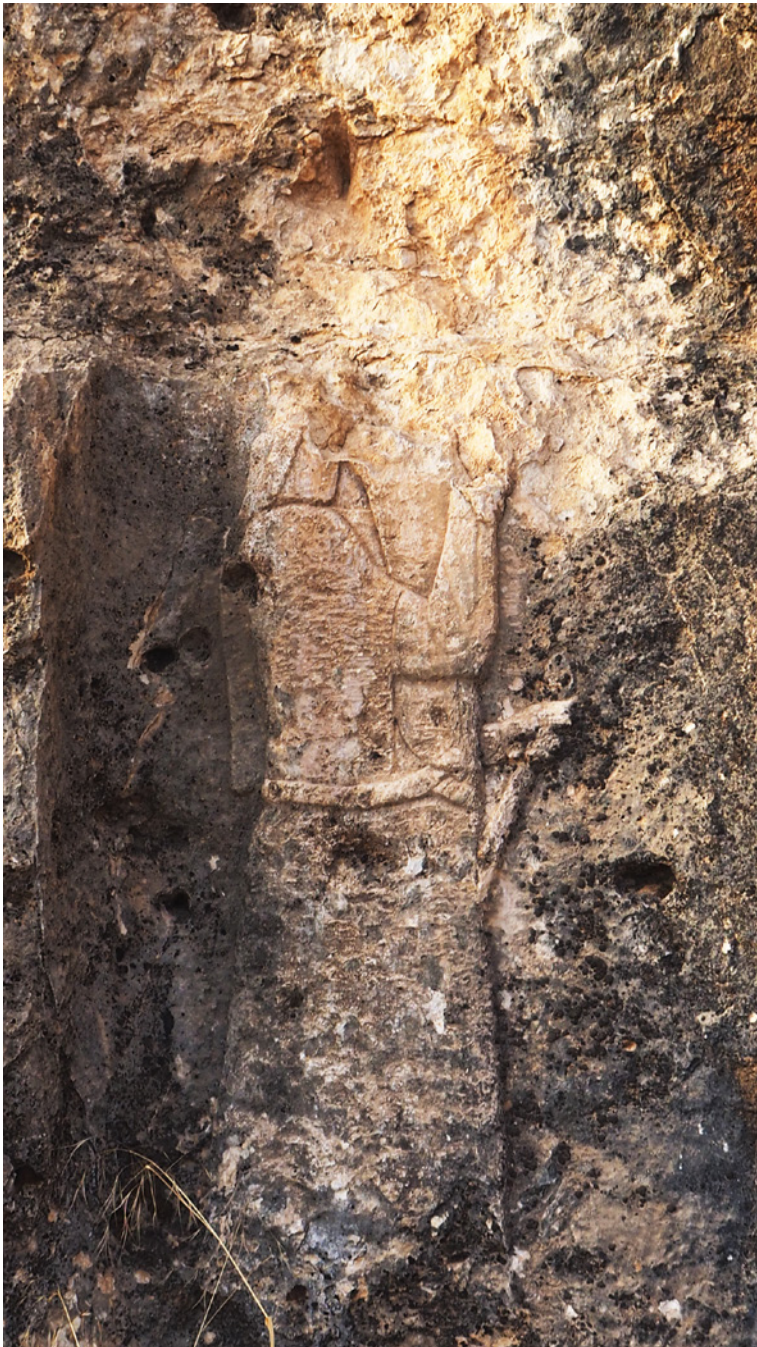
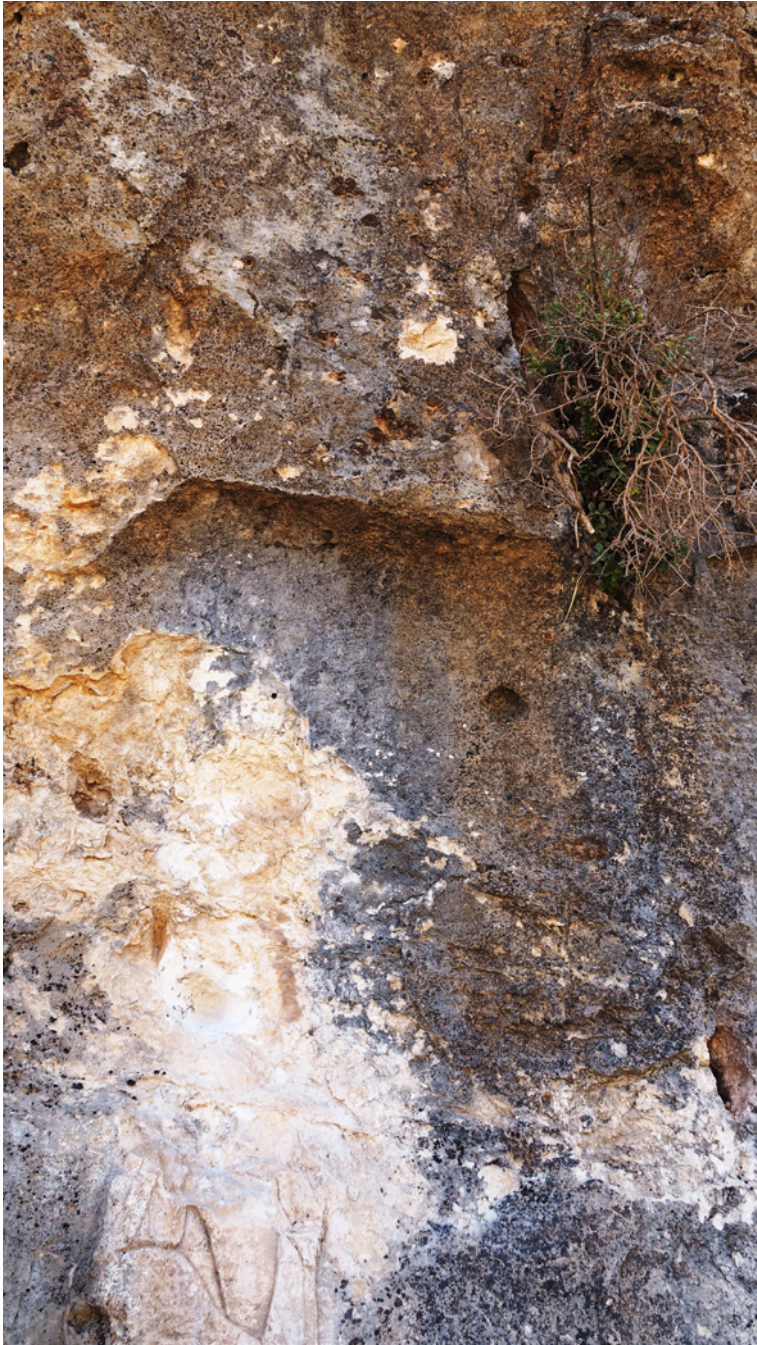
The following year, in May, Panel no. 4 was then subjected to deliberate acts of vandalism and destruction. The king's tiara, at the left extremity of the panel, had contained a nodule of dolomite and calcite, which was extracted, leaving an empty spot in the badly damaged tiara [fig. 17].

Figure 17a Lefthand ruler's figure on Maltai Panel no. 4 before damage

Figure 17b After the hole was dug in the sovereign's tiara (photography I. Finzi Contini)

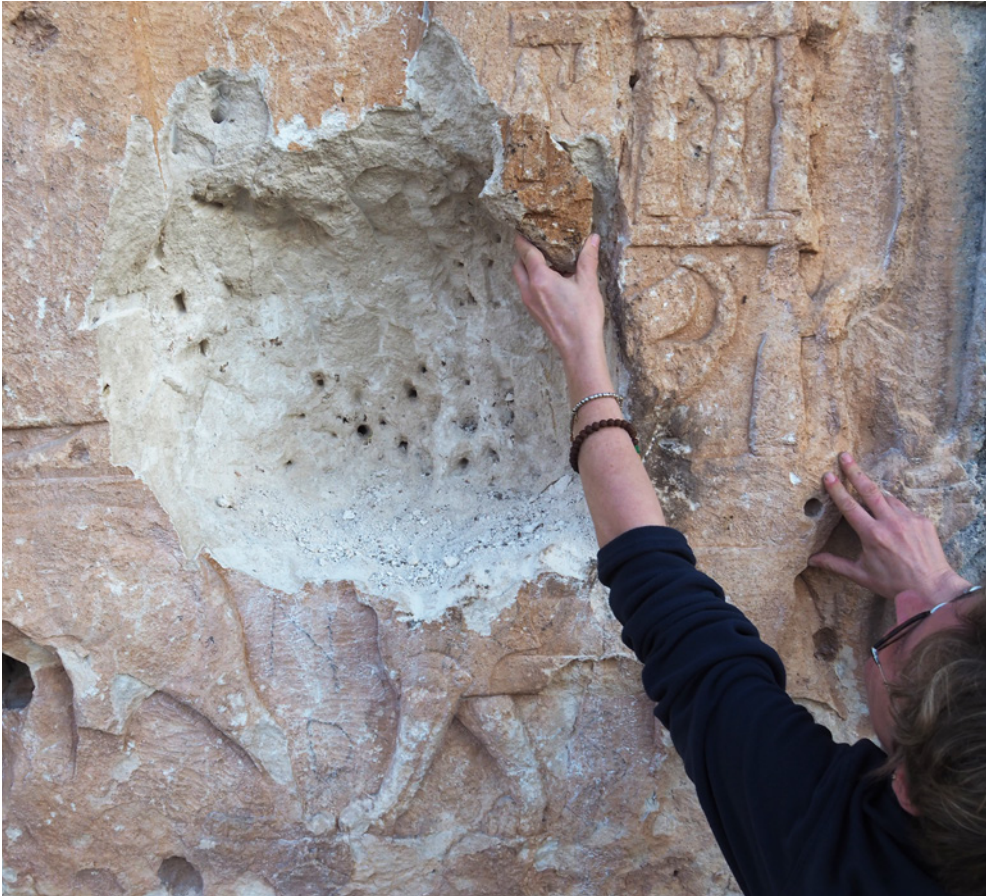
In February 2018, Panel no. 1 was damaged by an extreme act of vandalism which, along with those on Panels 2-4, make clear the extreme danger to which the Maltai rock reliefs are constantly exposed to due to their isolated position and the absence of an enclosing fence, as well as permanent guarding service to protect them. A sizeable hole measuring 55 × 56 cm and 36 cm deep dug with a pickaxe or ice axe devastated the lower part of the figure representing the goddess Mullissu, her throne and the head of the underlying lion, and partially destroyed the figure of the god Ashur in front of her [fig. 18] (Finzi Contini 2019, 203-4, figs. 24-8). As in the case of Panel no. 2 in Gunduk, the most probable cause for such destructive actions is a widespread belief in northern Iraq and eastern Turkey that ancient rock reliefs signalled the presence of ancient treasure hidden inside the rock behind them. Some fragments of the broken portion of the relief were recovered by the team of the University of Udine and the Duhok Antiquities Directorate and digitally recomposed [fig. 19]. Future restoration work will probably allow the recomposition of at least a part of the damaged portion of Panel 1.

Figure 18 Hole dug in Maltai Panel no. 1 (photography P. Pagnin)

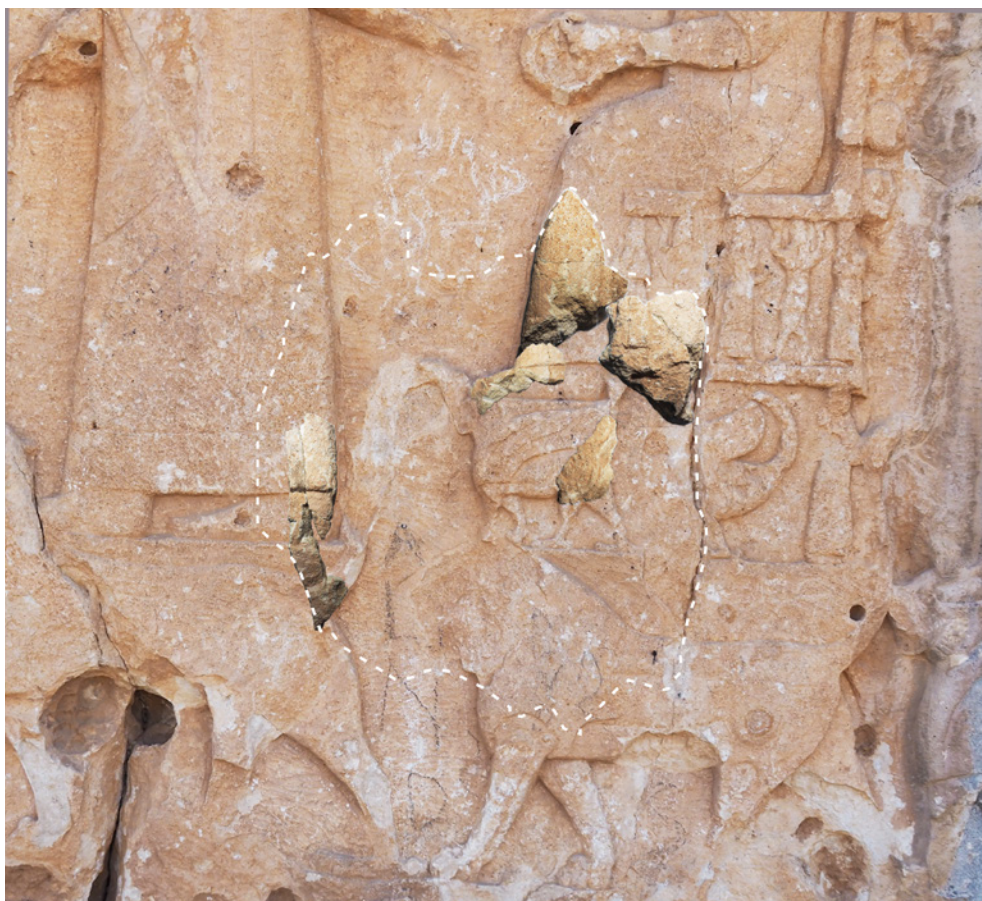
Figure 19 Digital recomposition of the recovered fragments of Panel no. 1 (I. Finzi Contini)

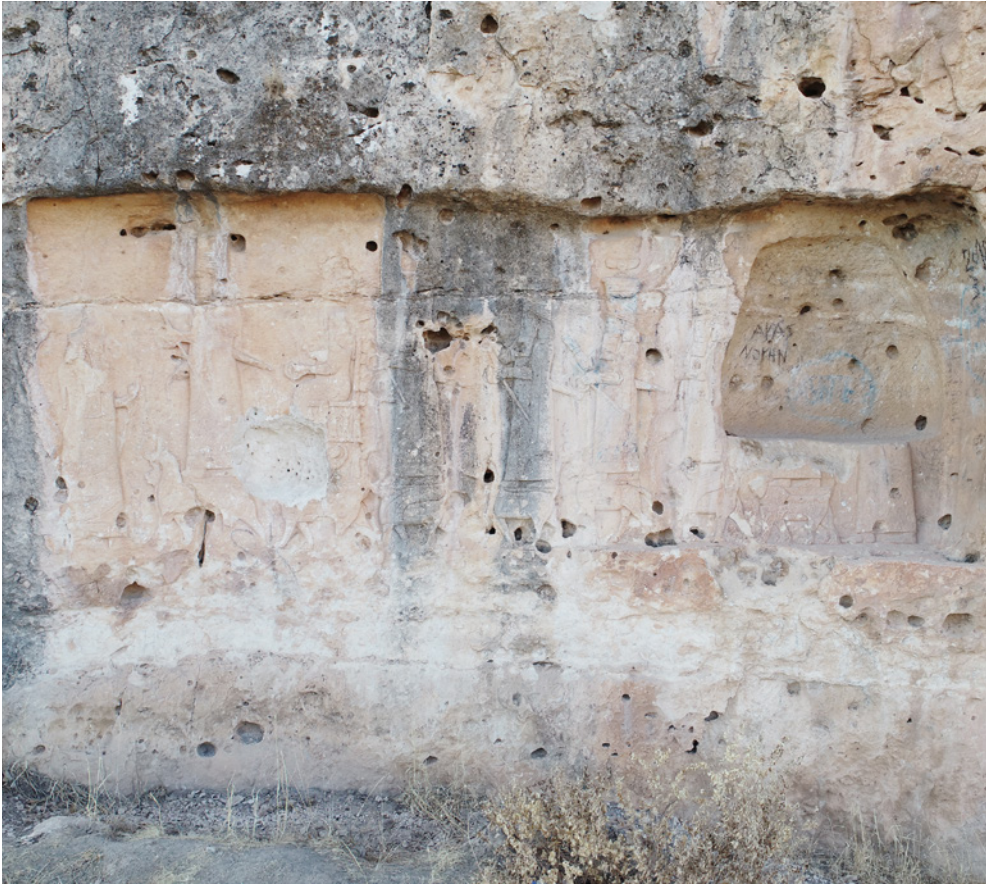
At the right extremity of Panel no. 1 a considerable hollow was dug, which has partially removed the upper part of the king's figure, the goddess Ishtar on the lion and a small part of the god Adad (Finzi Contini 2019, 203 and fig. 9). It is not clear if, as Reade hypothesized (1989, 321), this was an unfinished attempt to create a tomb inside the relief in antiquity, similar to that present in Panel no. 3 and dated to the first-third century CE, or rather a more recent excavation performed with the aim of extracting parts of the figures of the king and Ishtar.

Figure 20 Panel no. 1 with the hole dug in 2018 on the left, the large arched niche excavated at an unknown date on the right, and oil paint and charcoal graffiti (photography I. Finzi Contini)

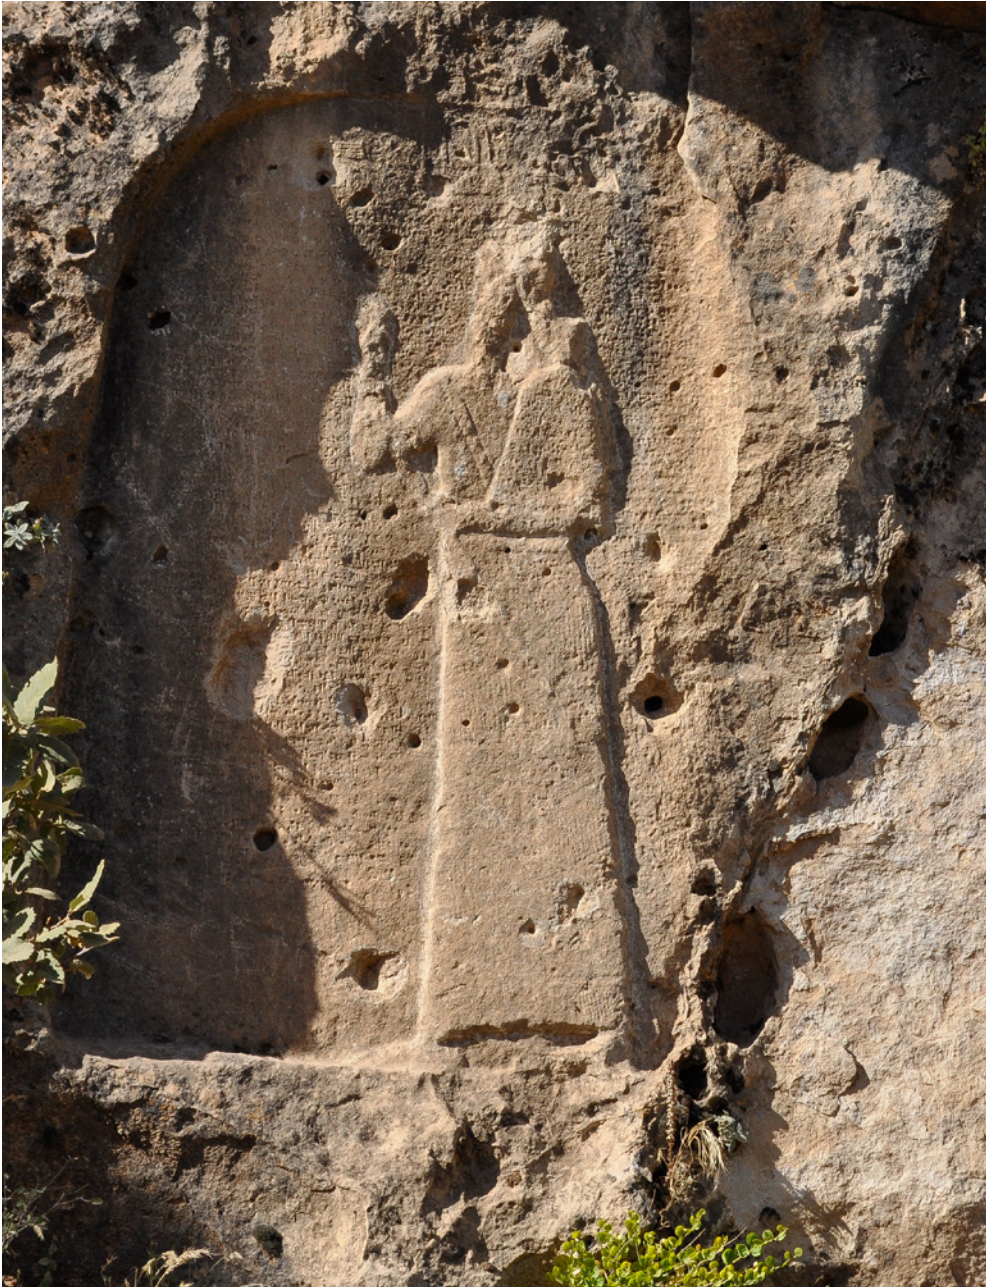
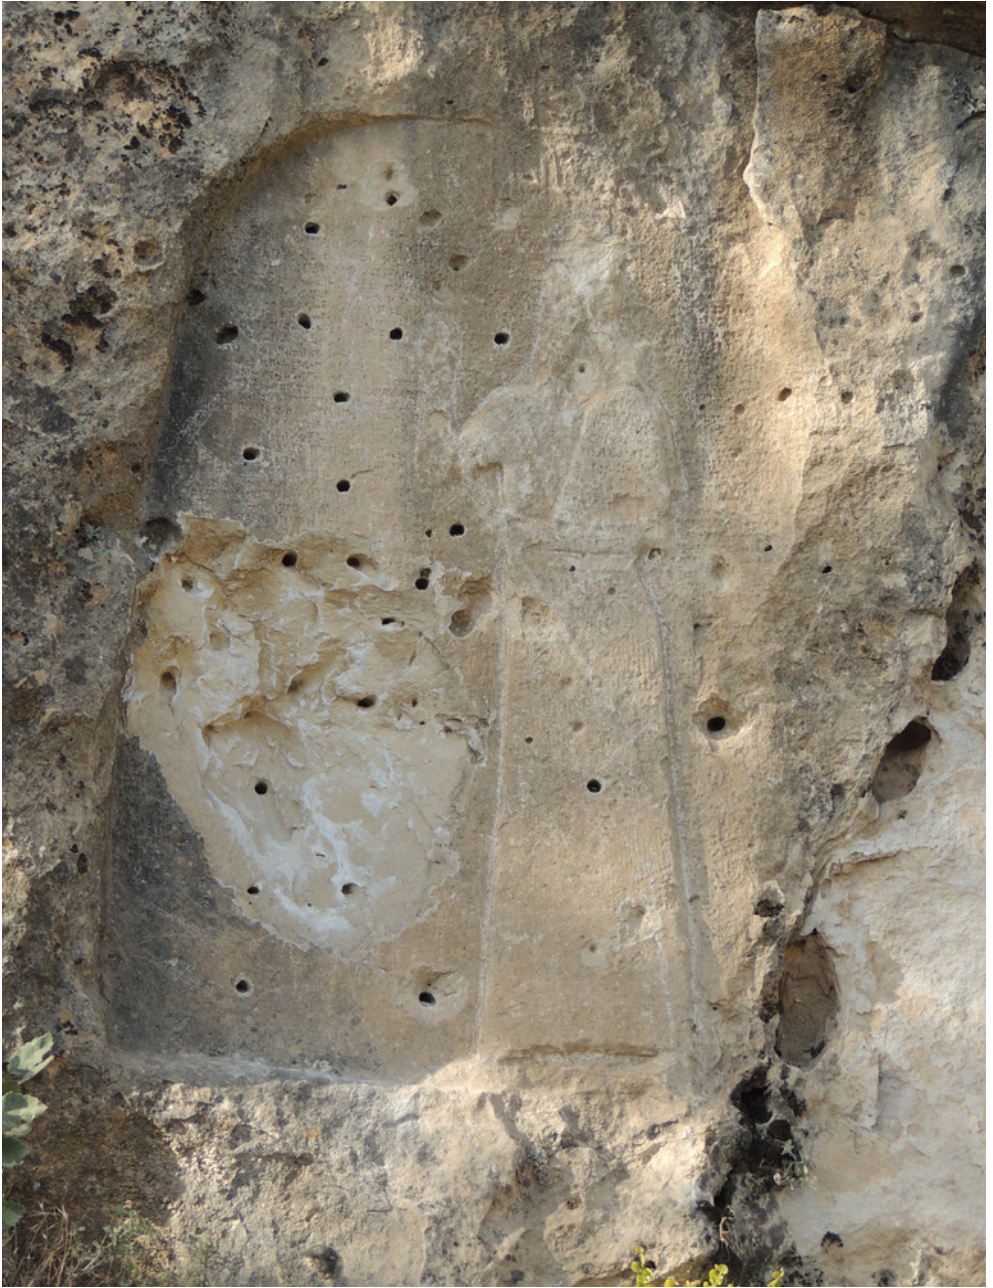
Thus the Mila Mergi stela, although located in a completely isolated position in the uninhabited mountains north of Duhok, has been gravely and irremediably damaged, presumably by treasure seekers.

Figure 21a The Mila Mergi rock stele in 2012 before it was damaged (photography A. Savioli)

Figure 21b After damage in 2013 (photography R. Orazi)
