Multidisciplinary Perspectives on Illicit Trafficking of Cultural Heritage in the EU and the MENA Region

Faces in Stone. Rock Art in the Duhok Region (Kurdistan Region of Iraq) A Seriously Threatened Cultural Heritage

Daniele Morandi Bonacossi

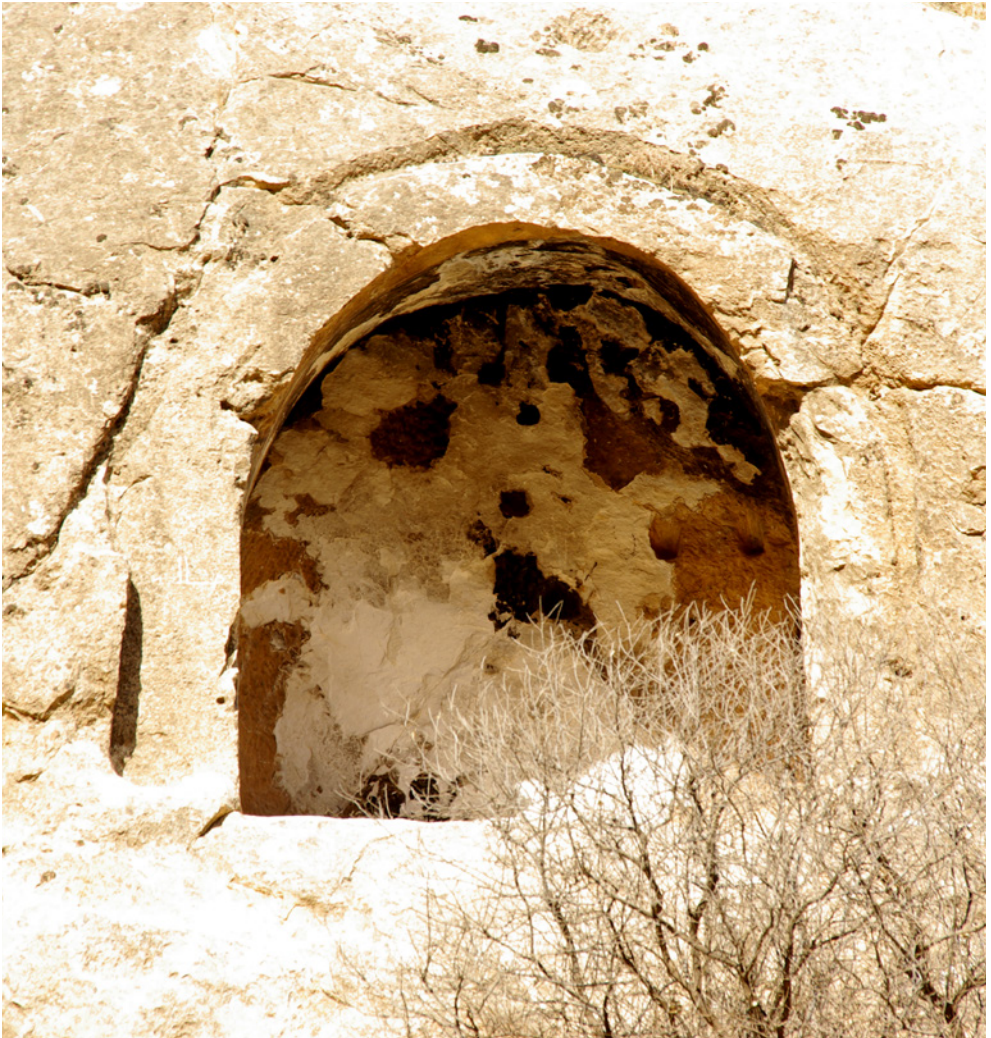
Figure 22 Arched niche with destroyed Parthian relief depicting a baetylus crowned by a Nike (photography G. Garna)

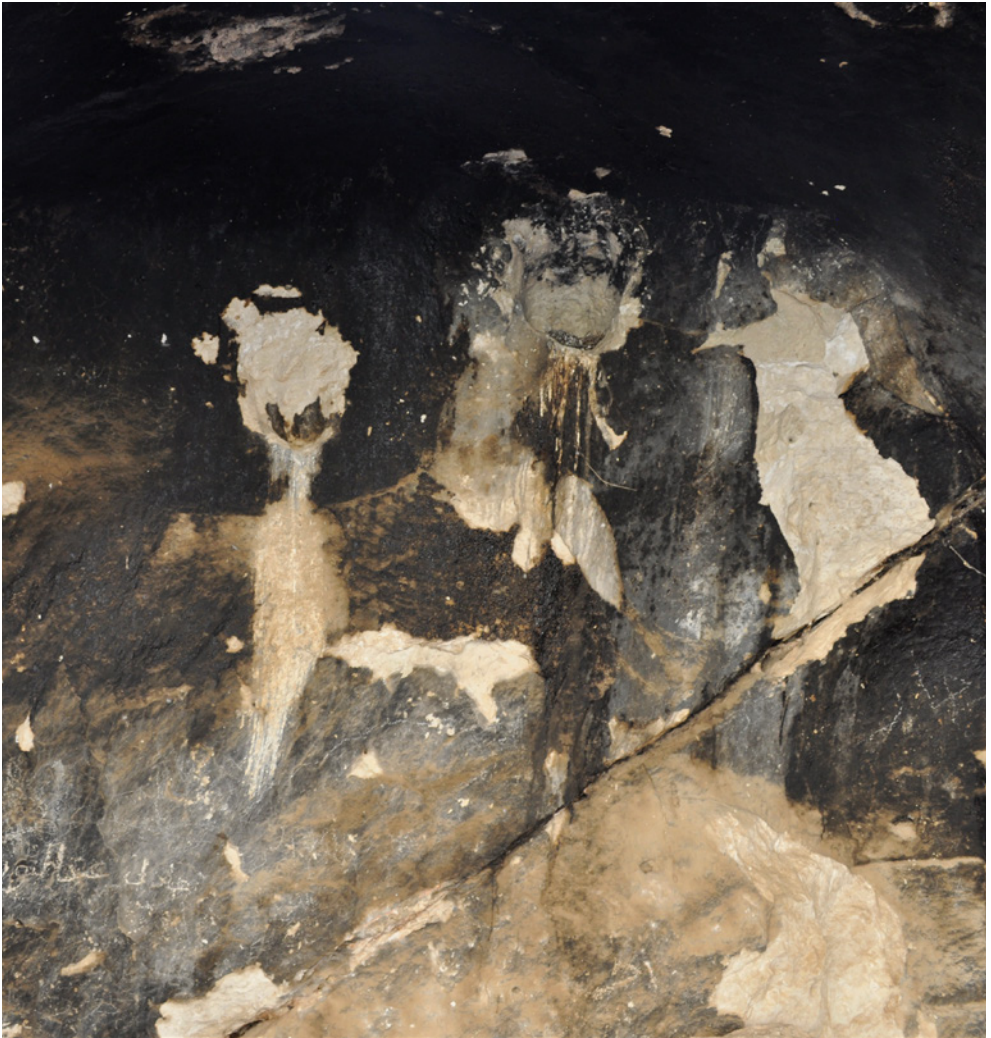
The second severely damaged rock relief of the Gali Zerdak complex can be probably dated to the Hellenistic period and might be a commemorative relief of the victory of Gaugamela in 331 BCE, carved by Alexander the Great in a position overlooking the battlefield, located near the site of Gir-e Gomel/Gaugamela, where he defeated the great Persian King Darius III (Wójcikowski, Morandi Bonacossi, Marciak forthcoming). The relief, located at the bottom of a large, deep hollow, depicts a horseman crowned by a Nike [fig. 23]. The body and head of the Winged Victory (except for the wings), the crown and its ribbons, the anterior part of the horse's body and part of the rider's torso were intentionally destroyed. Since the sculptured surfaces of the Nike, the horse's body and part of the horseman's torso were smashed, in the place of the crown the Winged Victory offered to him there is now a deep, circular hole. It seems that here too, as in the cases of Gunduk, Maltai and Mila Mergi, the damage was caused by treasure seekers.

Figure 23 Relief of a rider crowned by a Nike badly damaged by vandalism (photography G. Garna). The blackening of the sculptured surfaces is due to carbon from black smoke accumulated over the centuries due to the use of the large niche on the bottom of which the relief was carved as a shepherd's bivouac
